SAMPLE INSPECTION REPORT

1234 Anywhere Drive, Phoenix, AZ 85001

5/25/2009 7:00 am to 12:00 pm

SUMMARY INSPECTION REPORT

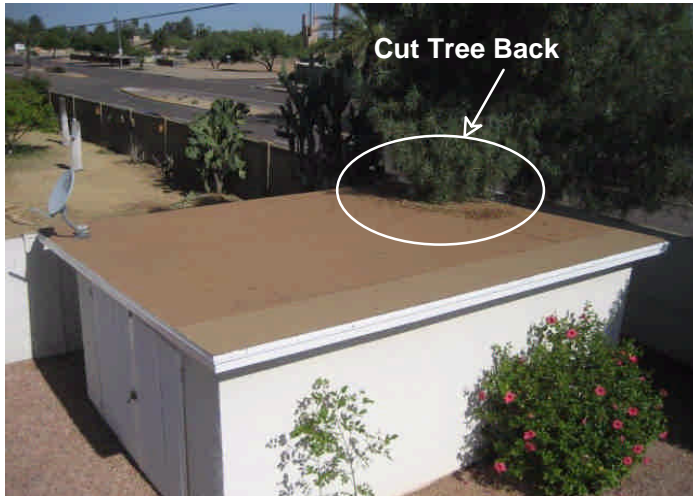
- 3.1 - A tree limb is threatening the roof eaves (storage shed), and should be removed by an arborist before it further damages the roof eaves.

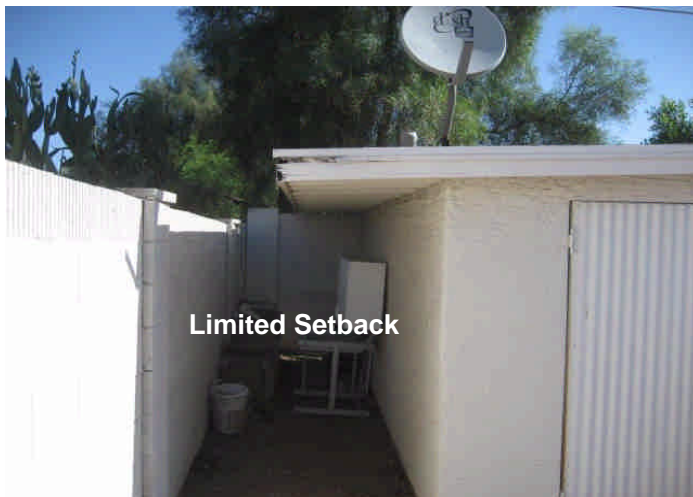
- 3.3 - The auxiliary structure may not have been built with a building permit and you may wish to have this verified by the local municipality.
- 3.4 - We do not have the expertise or the authority to establish property lines, which are determined by surveyors. However, using walls or fences as boundaries, a structure in the side yard encroaches on what would be the standard seven-foot setback. Therefore, you should verify the permit and the certificate of occupancy for this structure, because we do not endorse or tacitly approve of any structure built without a permit, and latent defects could exist.

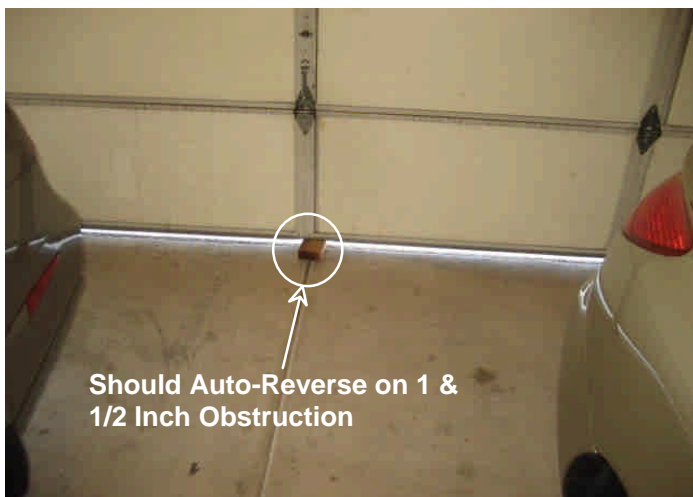
- 3.5 - The large garage door opener is functional, but it does not auto-reverse properly and should be adjusted to prevent injury or damage. We recommend that a qualified professional fully evaluate and adjust ALL functions of the garage door opener for proper operation.

- 3.6 - The pressure settings on both of the garage door openers need to be adjusted for safe operation when impacting an object during the opening or closing sequence. The garage door up pressure should be adjusted to allow the door to stop when it catches on something while opening, and the down pressure should be adjusted to stop, and open the door fully when catching on something while closing. We recommend that a qualified professional fully evaluate and adjust ALL functions of the garage door opener for proper operation.

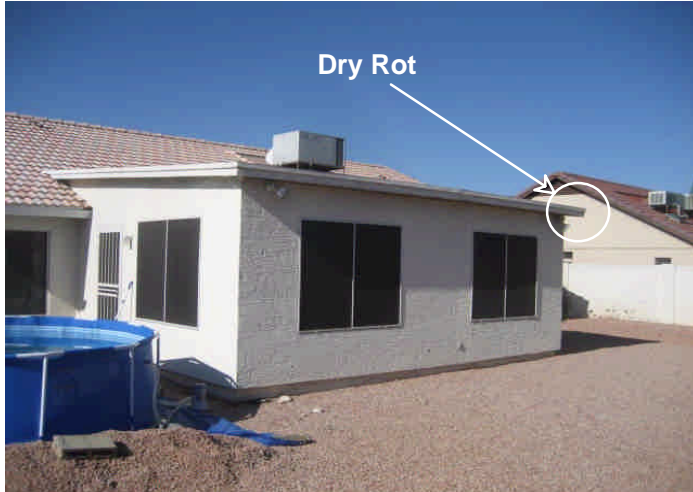
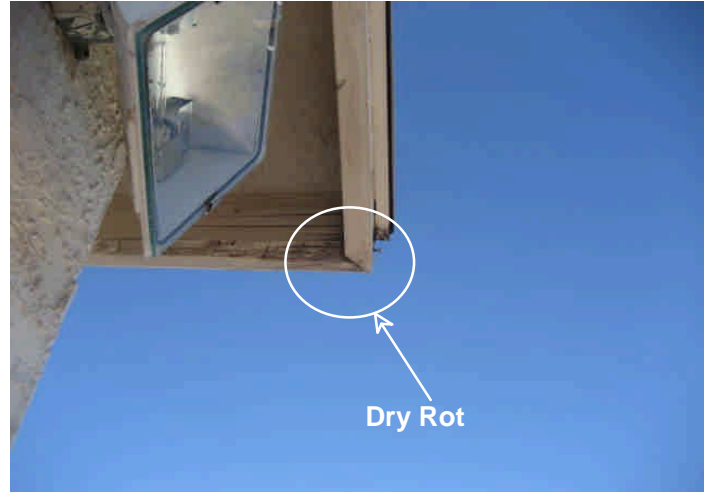
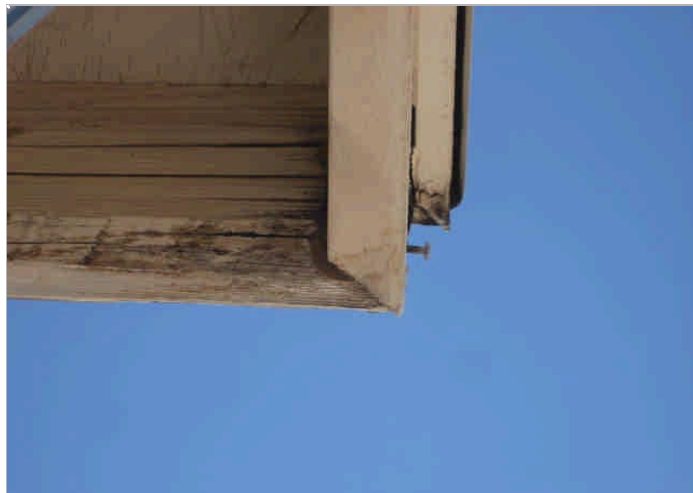
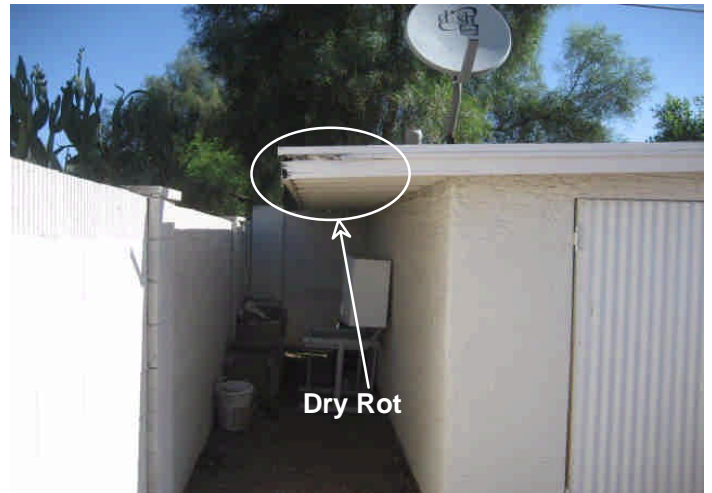
3.7 - The fascia board and trim (2 instances), is in poor condition (dry rot) and should be serviced.

- Left rear corner of family room addition
- Left front corner of storage shed (left rear corner of residence)

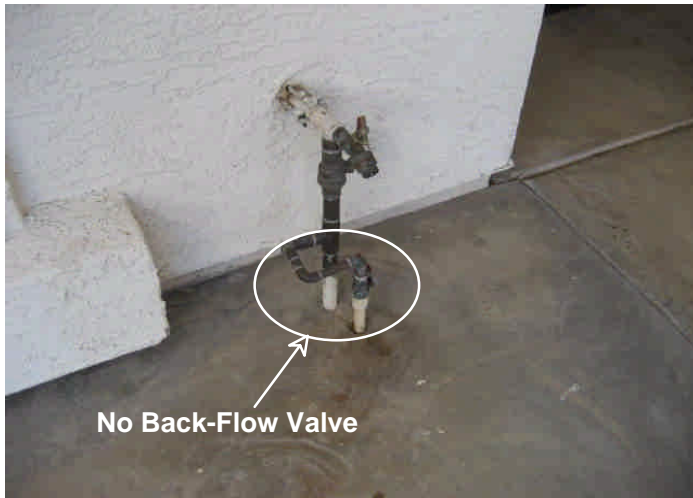
3.8 - The sprinklers do not incorporate anti-siphon or backflow valves (2 instances) that keep contaminated water from being drawn into the residence and should be added by a licensed plumber or landscape contractor.

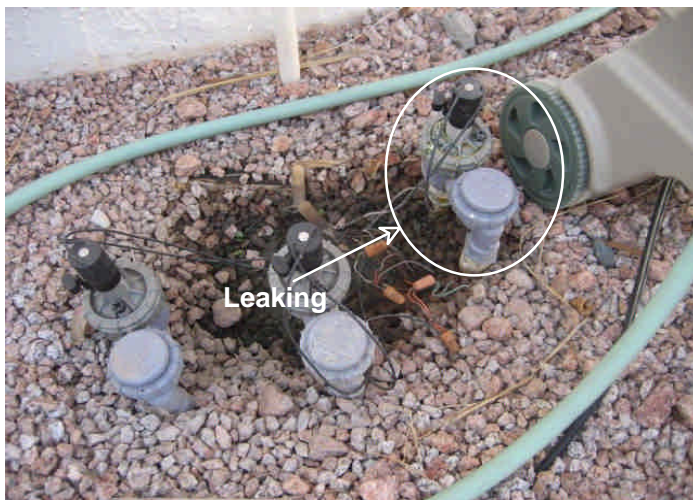
3.9 - The actuator(s) for the automatic sprinkler system is/are located at the left rear corner of the house, however one of these valves is leaking (right valve) and needs to be serviced by a qualified professional.

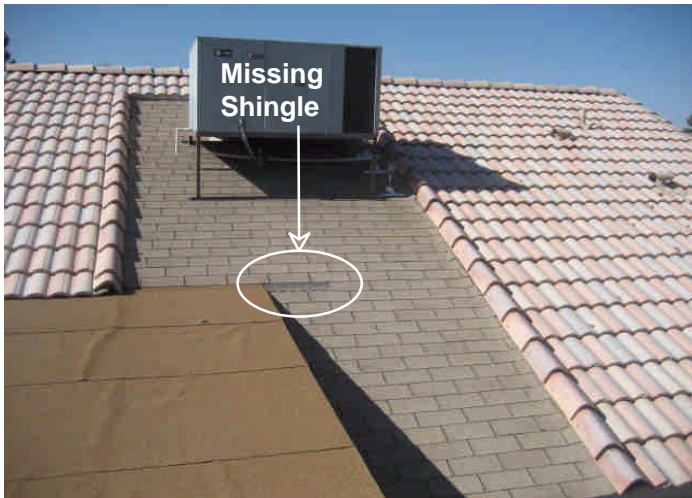
4.1 - There is a shingle missing from the composition shingle roof that should be repaired by a licensed roofer.

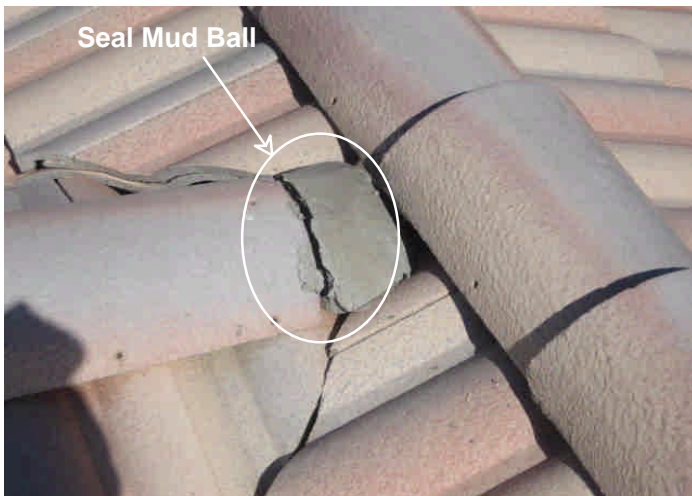
4.2 - The mud balls at the ridge junctions, which need to be sealed to prevent moisture intrusion into the roofing system by a licensed roofing contractor.

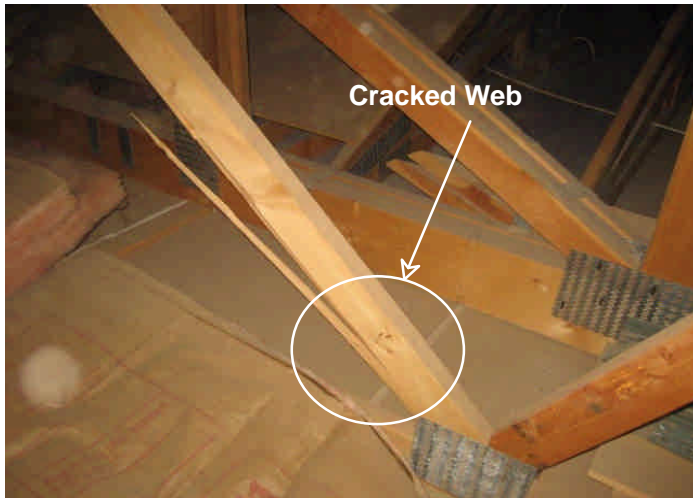
4.3 - One of the webs in the attic (above garage) is cracked or broken and should be repaired by a truss professional engineer.

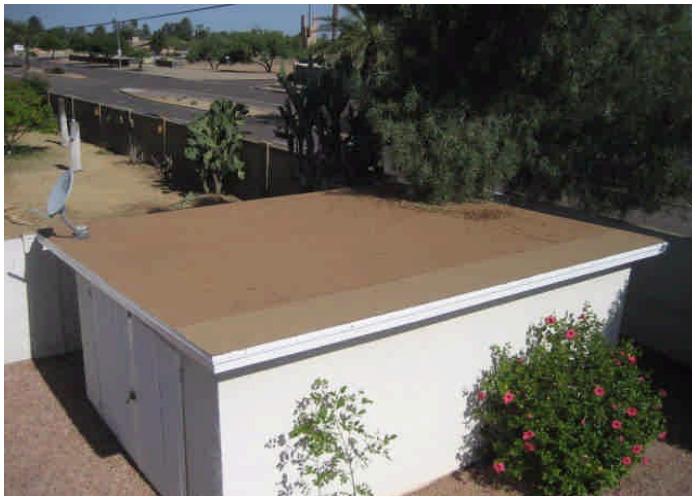
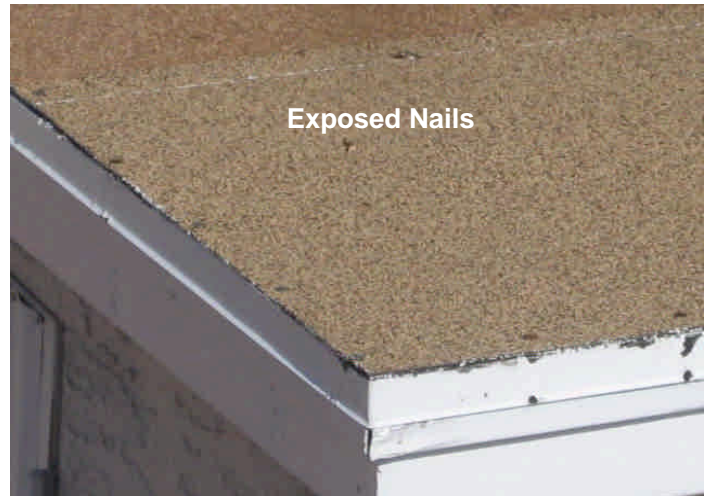
4.4 - This roof above the storage shed is in poor condition and should be repaired, replaced, or evaluated by a roofing contractor before the close of escrow, or it may leak.

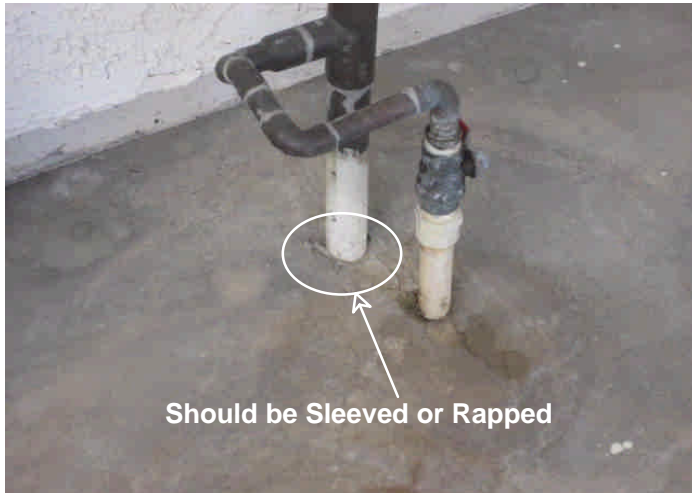
5.2 - The copper pipes at the front are not sleeved or wrapped to prevent the electrolytic condition that could result in leaks and should be serviced by a licensed plumber.

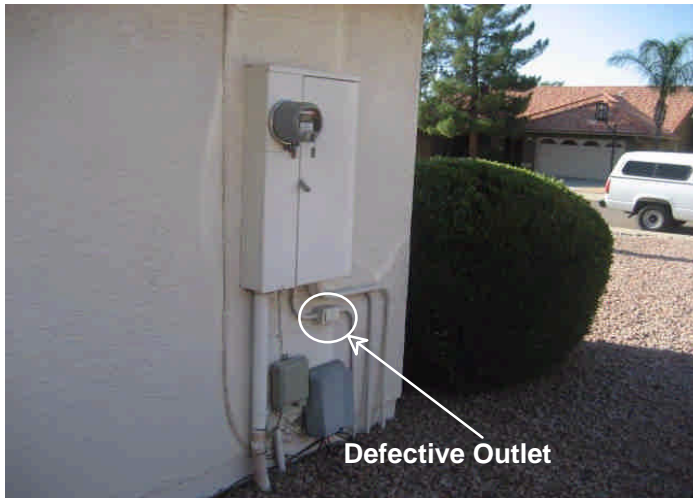
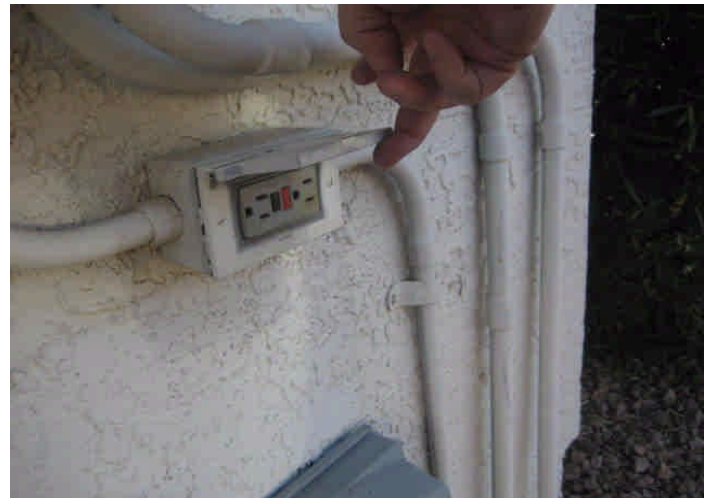
6.1 - The GFCI outlet below the main electrical panel is defective (does not trip on test) and should be replaced to have ground-fault protection by a licensed electrician.

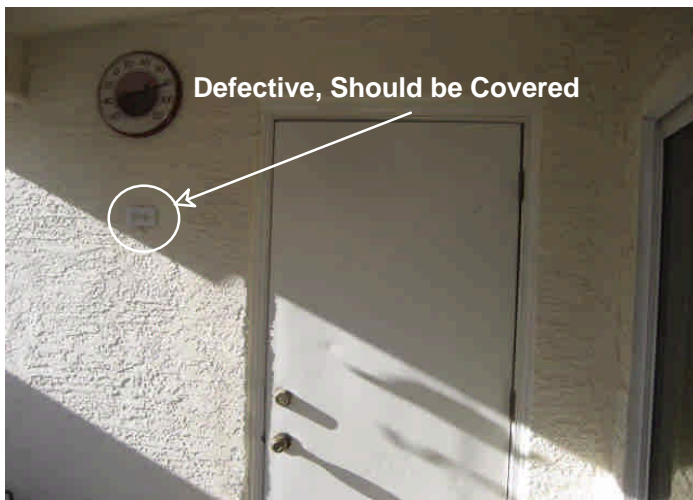
6.2 - An outlet in the right side yard of the house (at garage side door) is intermittent and should be upgraded to have ground-fault protection by a licensed electrician, and also should include a weather cover.

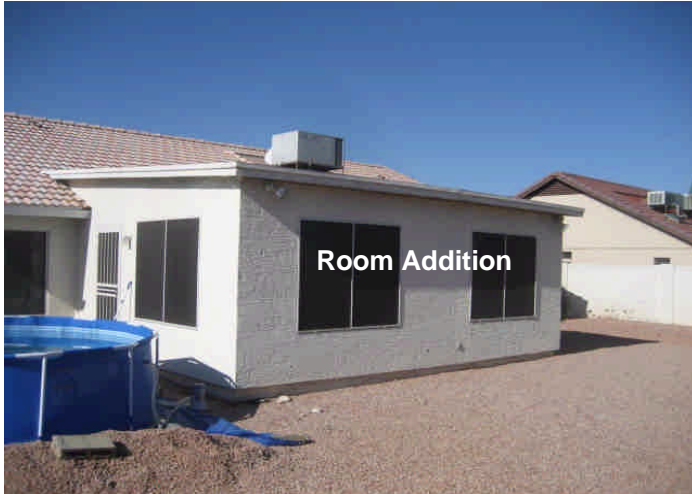
10.2 - The family room appears to have been remodeled or part of an addition. If so, we recommend that you verify the permit and certificate of occupancy. This is important because our inspection does not tacitly approve, endorse, or guarantee the integrity of any work that was done without a permit, and latent defects could exist.

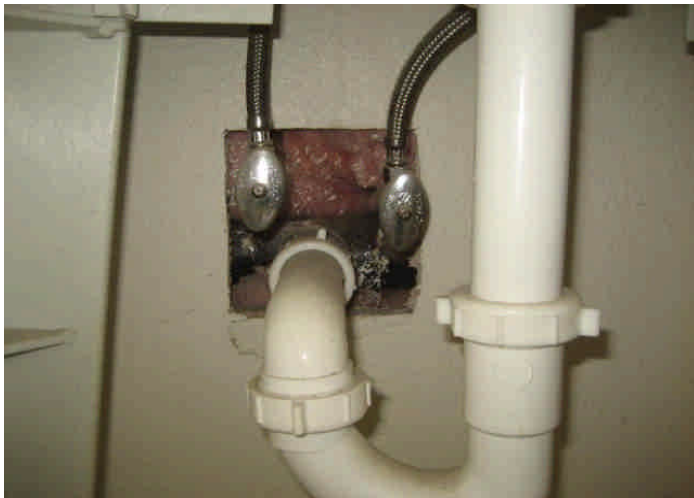
12.2 - The wall under the sink should be sealed to prevent pest intrusion.

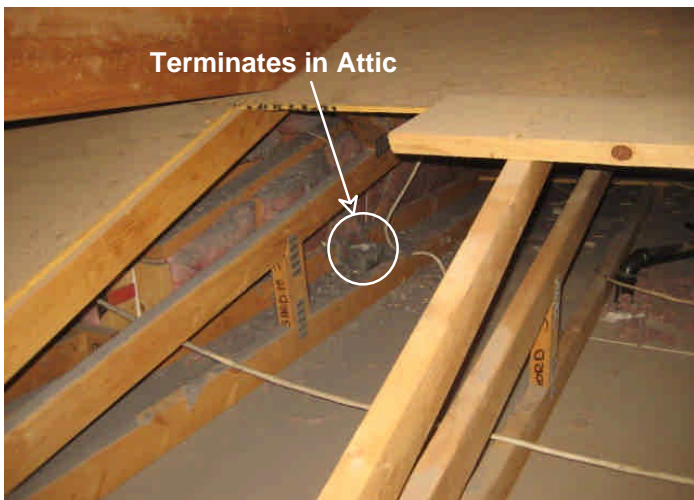
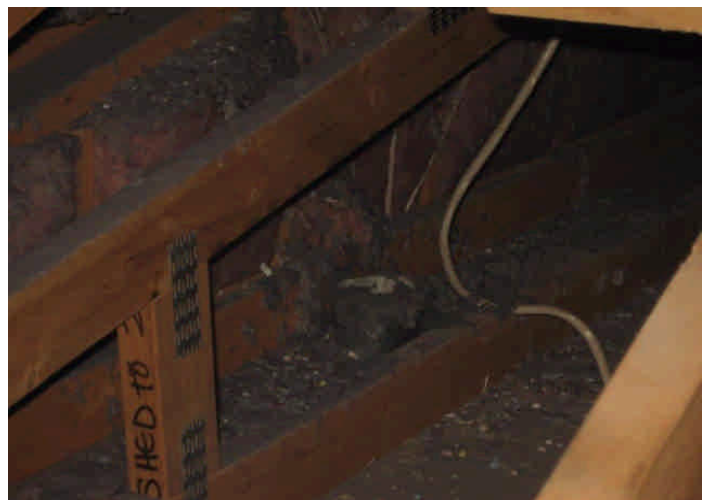
12.3 - The dryer vent is separated within the attic and should be extended to terminate above the roof and needs to be serviced by a qualified professional.

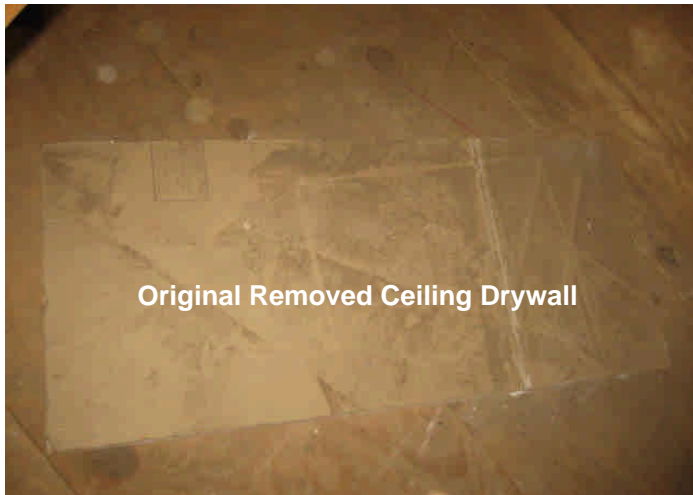
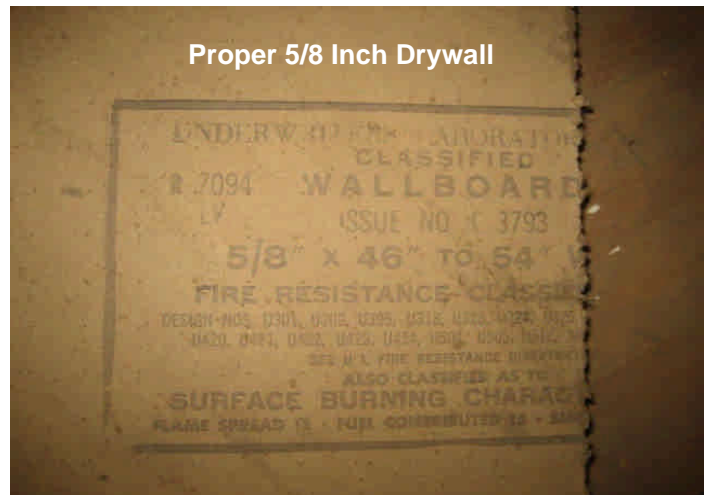
12.7 - The 1/2 inch drywall cover to the attic area should be 5/8 inch drywall, in order to provide a firewall separation between the garage and the living quarters.

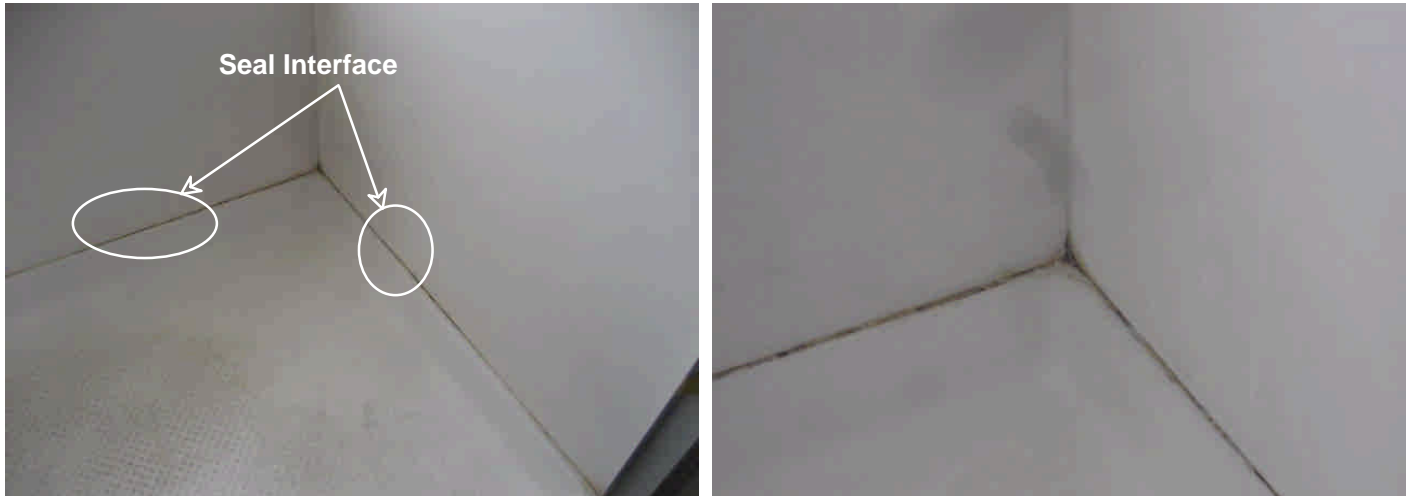
15.1 - There are open joints in the stall shower cultured marble that should be sealed to prevent moisture damage.
